## Development of Risk Management Guide Lines for Slope Stability Problem at Nchanga Open Pit (Nop) Mine, Zambia

**Abstract:** Nchangaopen pit (NOP) slope stability problems have been identified for decades. These problems have been attributed to poor understanding of the rock mass strength, its deformability characterization in addition to lack of understanding of the risk and its analysis. These deficiencies have caused failure of the production slope resulting in fatal accidents, economic losses and above all affecting the morale of mine workers. To address these problems, the rock mechanics research team of the University of Zambia, School of Mines carried out an exercise to come up with risk management guidelines. The paper reports on the outcomes of the research at NOP. The methodology in the research programme involved drill core logging and use of some special soft wares.

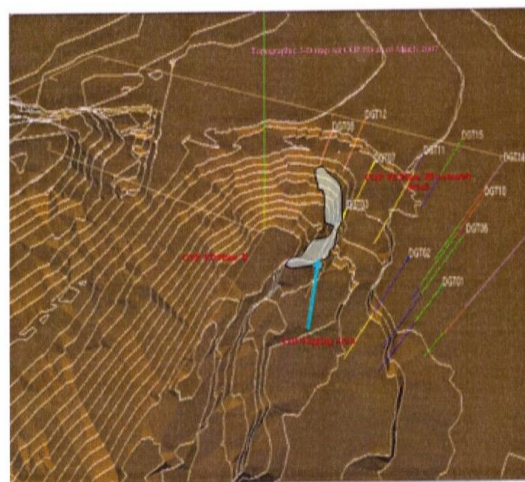
Figures 1, Nchanga Open Pit Mine Research Site aerial view (3-D)

The Nchanga – Chingola region Open Pit F and COP F/D Phase III was the studyarea where this research was carried out.

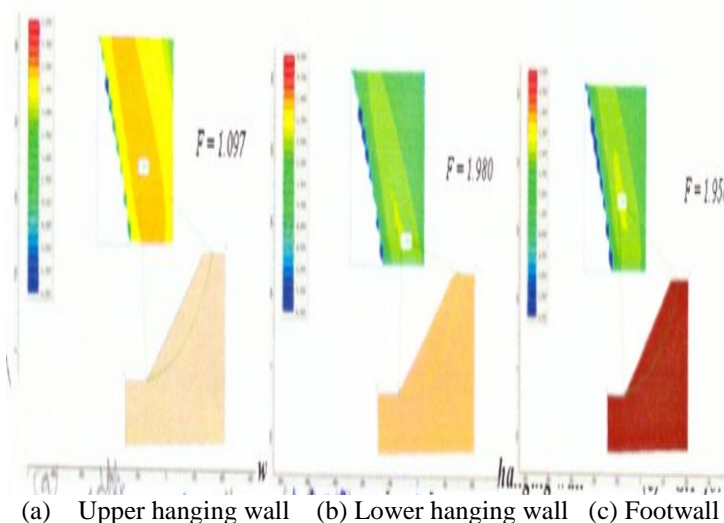
Figure 2: Factors of safety (FS) of (a) upper hanging wall, (b) lower hanging wall and (c) Footwall for three different sections (PHASE 2)
